I wanted to send you a letter to let you know that Maggio's Roofing has completed their work here at St. Edwards and we have a new flat roof! Thanks to your consistent generosity, we did not even need to have a special capital campaign to get our new flat roof! I wanted to share some before and after pictures so you could see how wonderful the changes are.

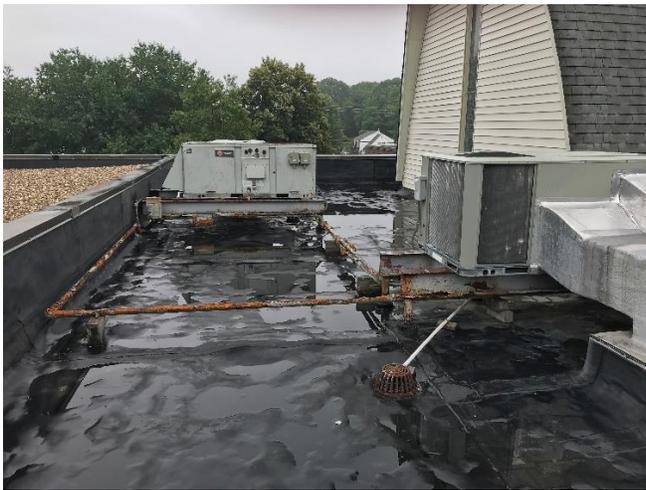
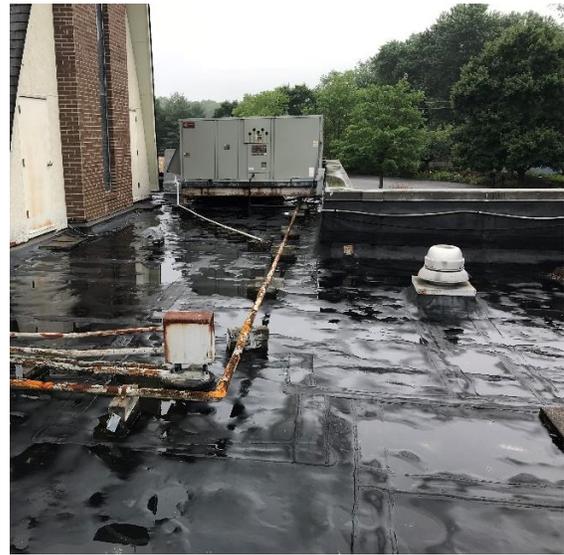
Here are some pictures of what the old roof looked like:

The insulation that was under the original roof was foam and would expand and contract. As you can see, the old flat roof did not look very flat at all! It looked like the surface of the moon. When it would rain, the rain water was unable to flow to the drains. Water would pool on the roof in these big puddles as you can see in the pictures above. When the sun would hit the puddles, it would act like a magnifying glass, heat up and dry out the rubber roofing material underneath. The result would be that over time the rubber roofing material would expand and contract causing tears in the roofing material that would eventually leak water onto the ceiling in the Church below.

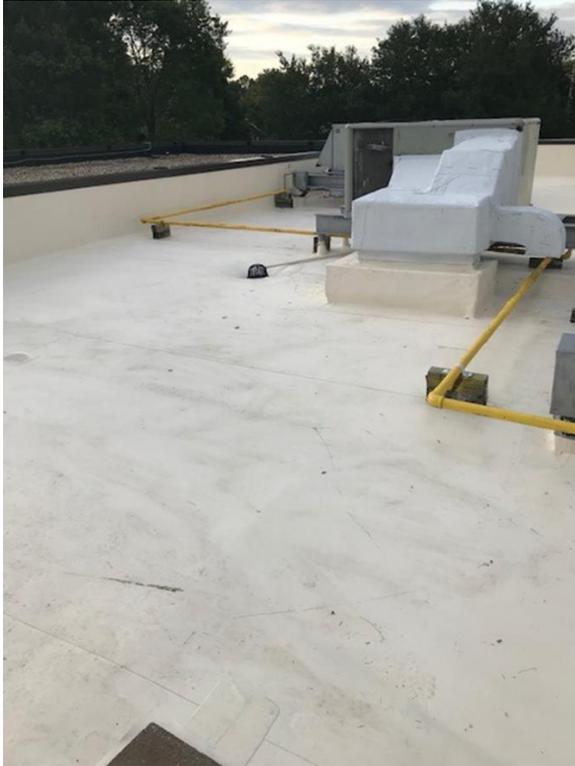
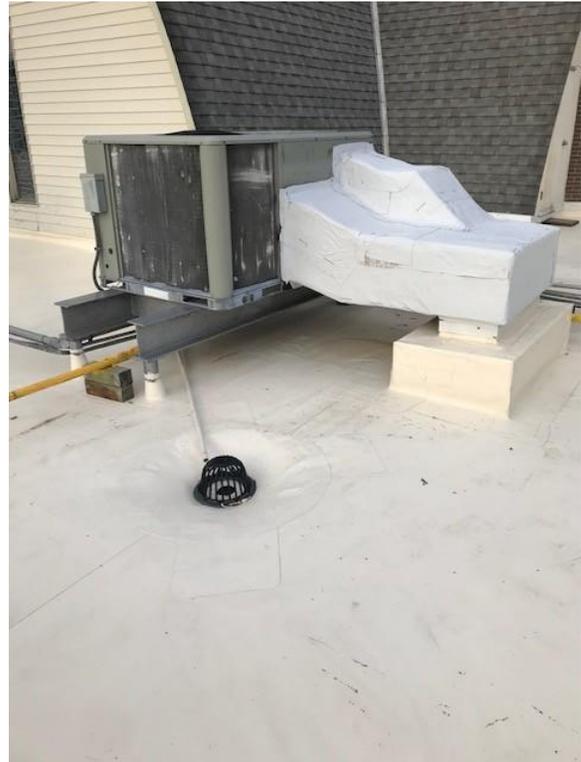
You can immediately see how much flatter the roof is. The roofing material is also white to reflect the sun to keep the interior of our Church cooler to lower our electric bill in the summer and so that the roofing material itself will not heat up as much.

You will also notice that they replaced the drains and kept them sunken below the level of the rest of the flat roof so that water will drain to them. While it is hard to see in these pictures, the insulation board underneath the white FiberTite roofing material actually is tapered to lead the water to the drains.

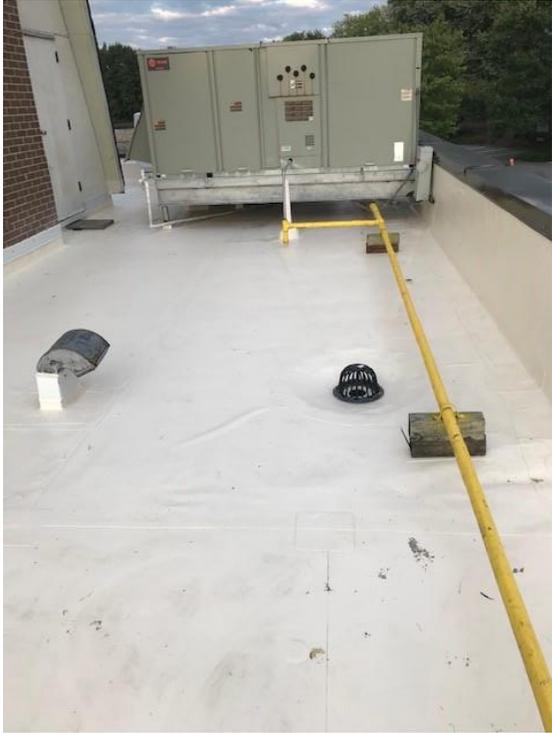
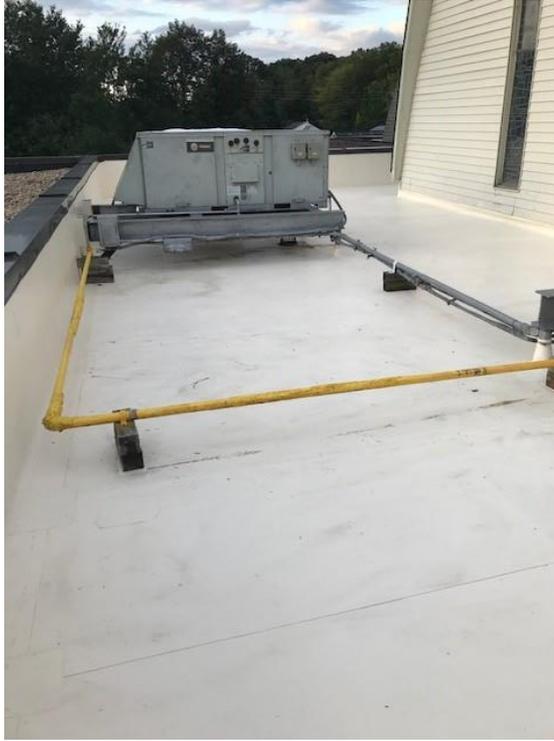
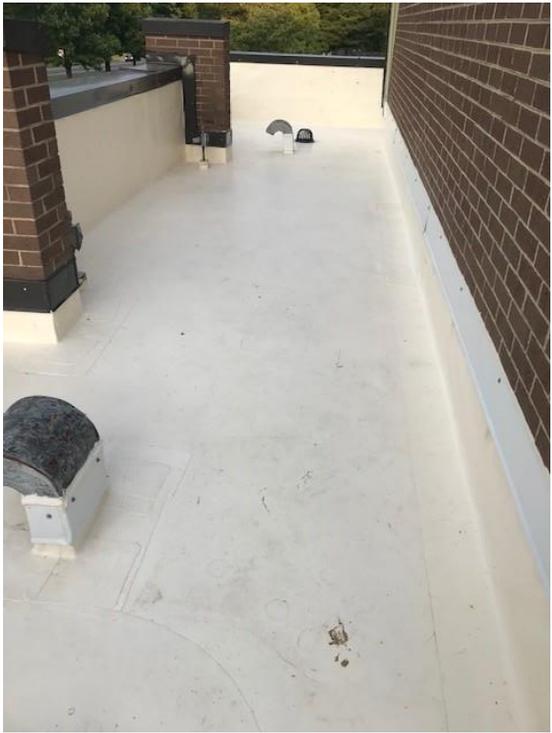
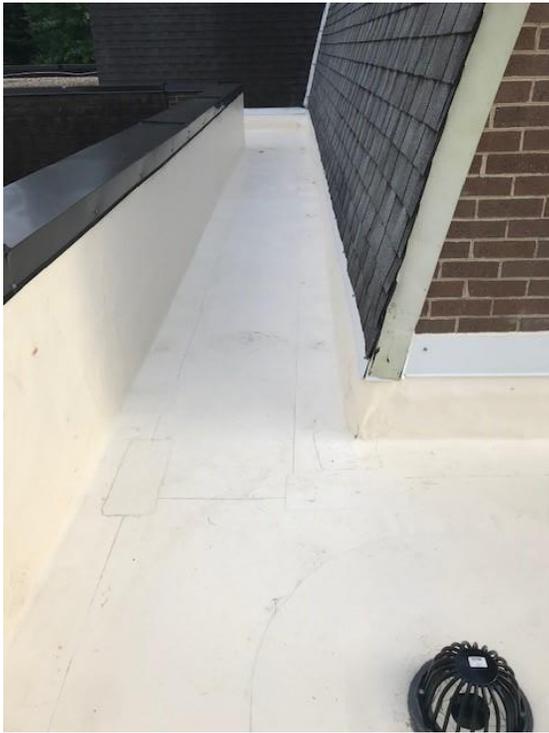
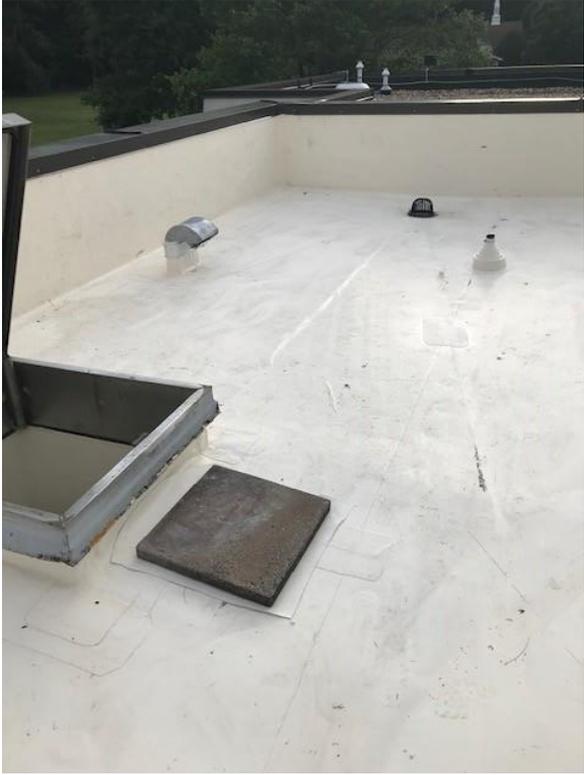
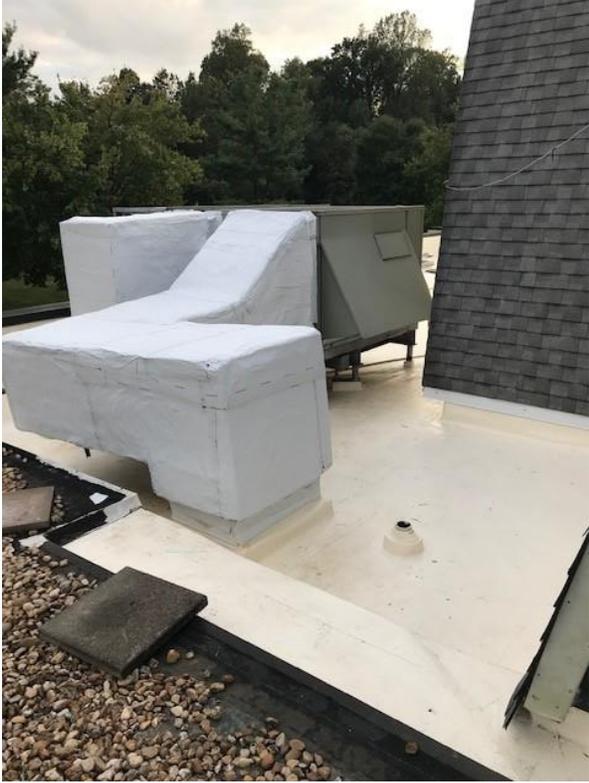
On the next couple of pages, you will see some additional pictures of our beautiful new flat roof. As you will see, the flat roof that was replaced was the original flat roof that wrapped around the pitched Church roof. Workers had to work around and under large air conditioning units to accomplish the job. They wrapped the air conditioning ducts with insulation as well because it needed replacement.
